Structures Technical Memorandum 359

**A REVIEW OF AUSTRALIAN INVESTIGATIONS ON
AERONAUTICAL FATIGUE DURING THE PERIOD
APRIL 1981 TO MARCH 1983**

MARCH, 1983

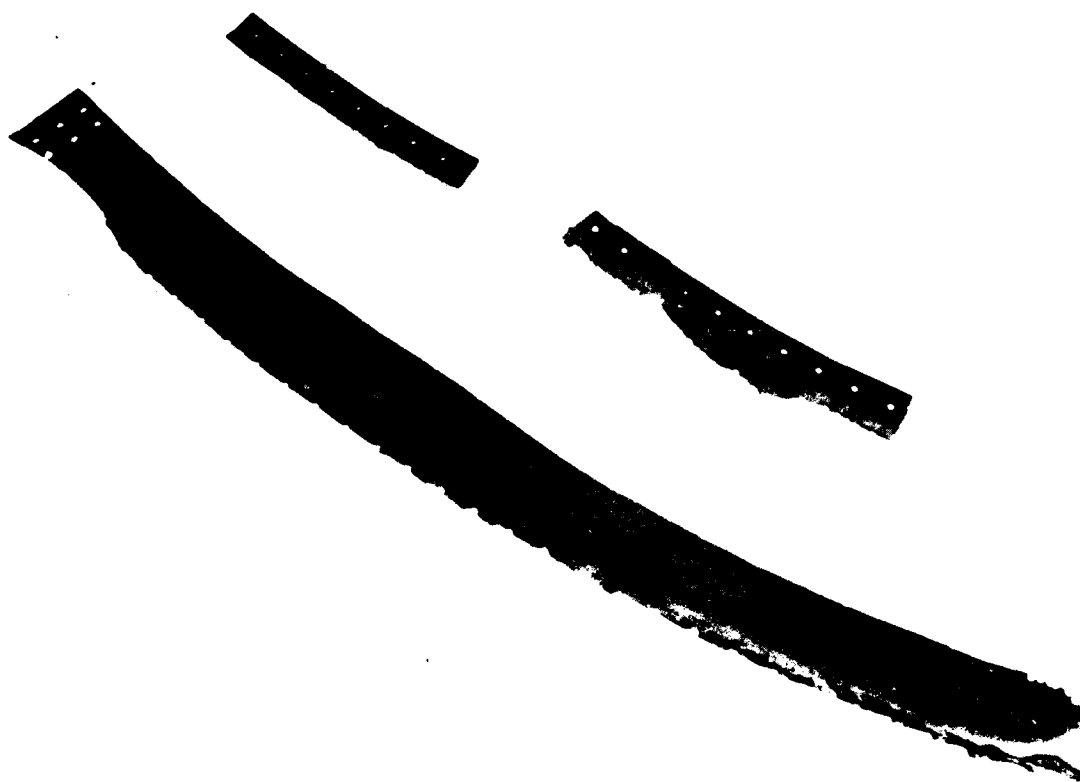
FIG. 9.7(a) LOCKHEED REAR BULKHEAD FATIGUE FRACTURES (x0.3)

After the flight crew of the freighter aircraft reported difficulties with the pressurisation system, an investigation of the equipment bay aft of the rear pressure bulkhead revealed obvious trauma to the thermal insulation blanket. Visual inspection of the bulkhead revealed a 54 cm circumferential crack in the pressure web on the left hand side of the aircraft, with a corresponding 16 cm crack in the underlying doubler, and a 15 cm crack in the web on the right hand side. The aircraft total time in service was 49 470 hours, 38 469 landings. The cracked sections of the bulkhead are shown in Fig. 9.7(a).
